**SUBJECT:** CLEAN AIR ACT INSPECTION REPORT  
Chicago Port Railroad Terminals, Chicago, Illinois

**Facility Name:** Chicago Port Railroad Terminals

**Purpose of Inspection:** Fugitive dust inspection

**Facility Type:** Bulk solid storage handling facility

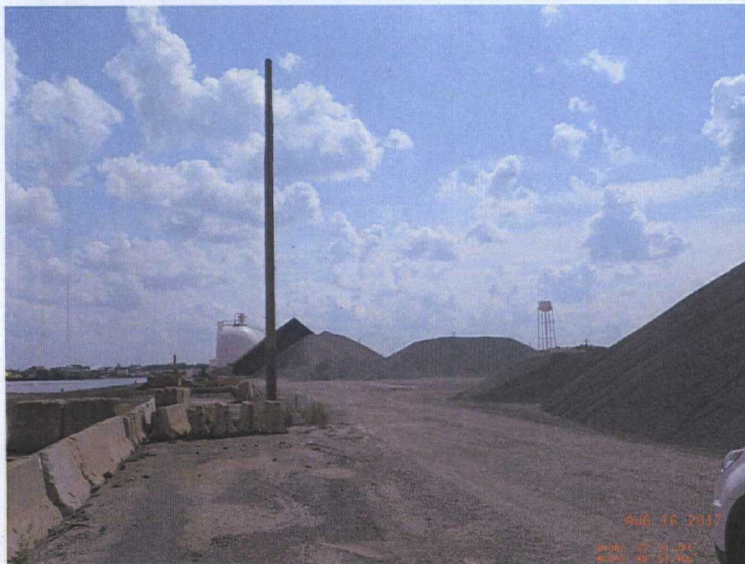
**RIMG0010**

EPA noted prior to beginning the tour, fugitive dust was exiting the site, across the property line, at the entrance to the facility. During the tour, EPA noted significant amounts of dust generated from the unpaved and un-watered roadways. Visibility from the car during the driving portions of the tour were obstructed occasionally. EPA was informed the site had a working water truck, but did not see the truck treating the roadways adjacent to the Calumet River. EPA noted to Mr. Saldarelli, Jr. that dust was crossing the property line into the Calumet River during the tour.

<b>Image Number</b>	<b>File Name</b>	<b>Date and Time (incl. Time zone and DST)</b>	<b>Latitude and Longitude</b>	<b>Description of Image</b>
RIMG0010	RIMG0010	August 16, 2017 at 2:23 PM	NA	Looking south along Calumet River from roadway
RIMG0011	RIMG0011	August 16, 2017 at 2:32 PM	NA	Looking south along Calumet River from roadway inside of car
